Intel® Celeron™ Processor Specification Update

Release Date: May 1999

Order Number: 243748-014

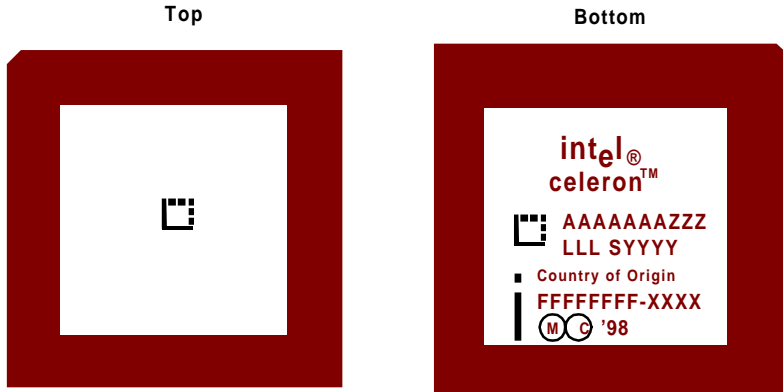
Intel® Celeron™ Processor and Boxed Intel® Celeron™ Processor Markings (PPGA Package)

- AAAAAAA = Product Code
- ZZZ = Processor Speed (MHz)
- LLL = Integrated Level-Two Cache Size (in Kilobytes)
- SYYYY = S-Spec Number
- FFFFFFFF-XXXX = Assembly Lot Tracking Number
